Interferences

Display

MyChron5 display is darkened, turns upside down, shows black lines and rolling numbers, turns off. What's going on?

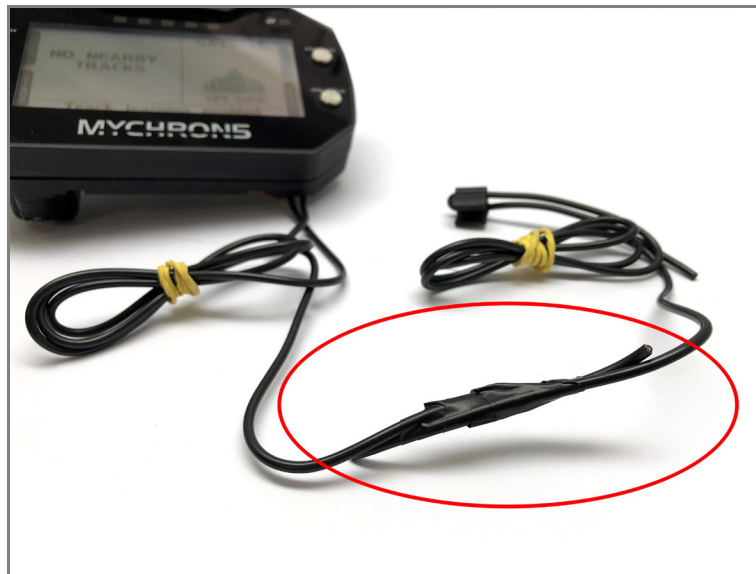
- the use of resistive/shielded spark caps
- the reduction of coils around the sparkplug cable of RPM pickup wire
- to cut the RPM pickup wire, then match the two wire far ends and tape them together (following image; **isolate them completely**) in order to reduce the signal intensity. If the signal should be too low, increase the number of coils around the sparkplug cable of RPM pickup wire
